A G E N D A
CITY OF AZTEC
CITY COMMISSION WORKSHOP
April 26, 2016
201 W. Chaco, City Hall
5:15 p.m.

A G E N D A
City of Aztec
CITY COMMISSION MEETING
April 26, 2016
201 W. Chaco, City Hall
6:00 p.m.

**City of Aztec
Parks and Recreation Enhancement Plan
2016**

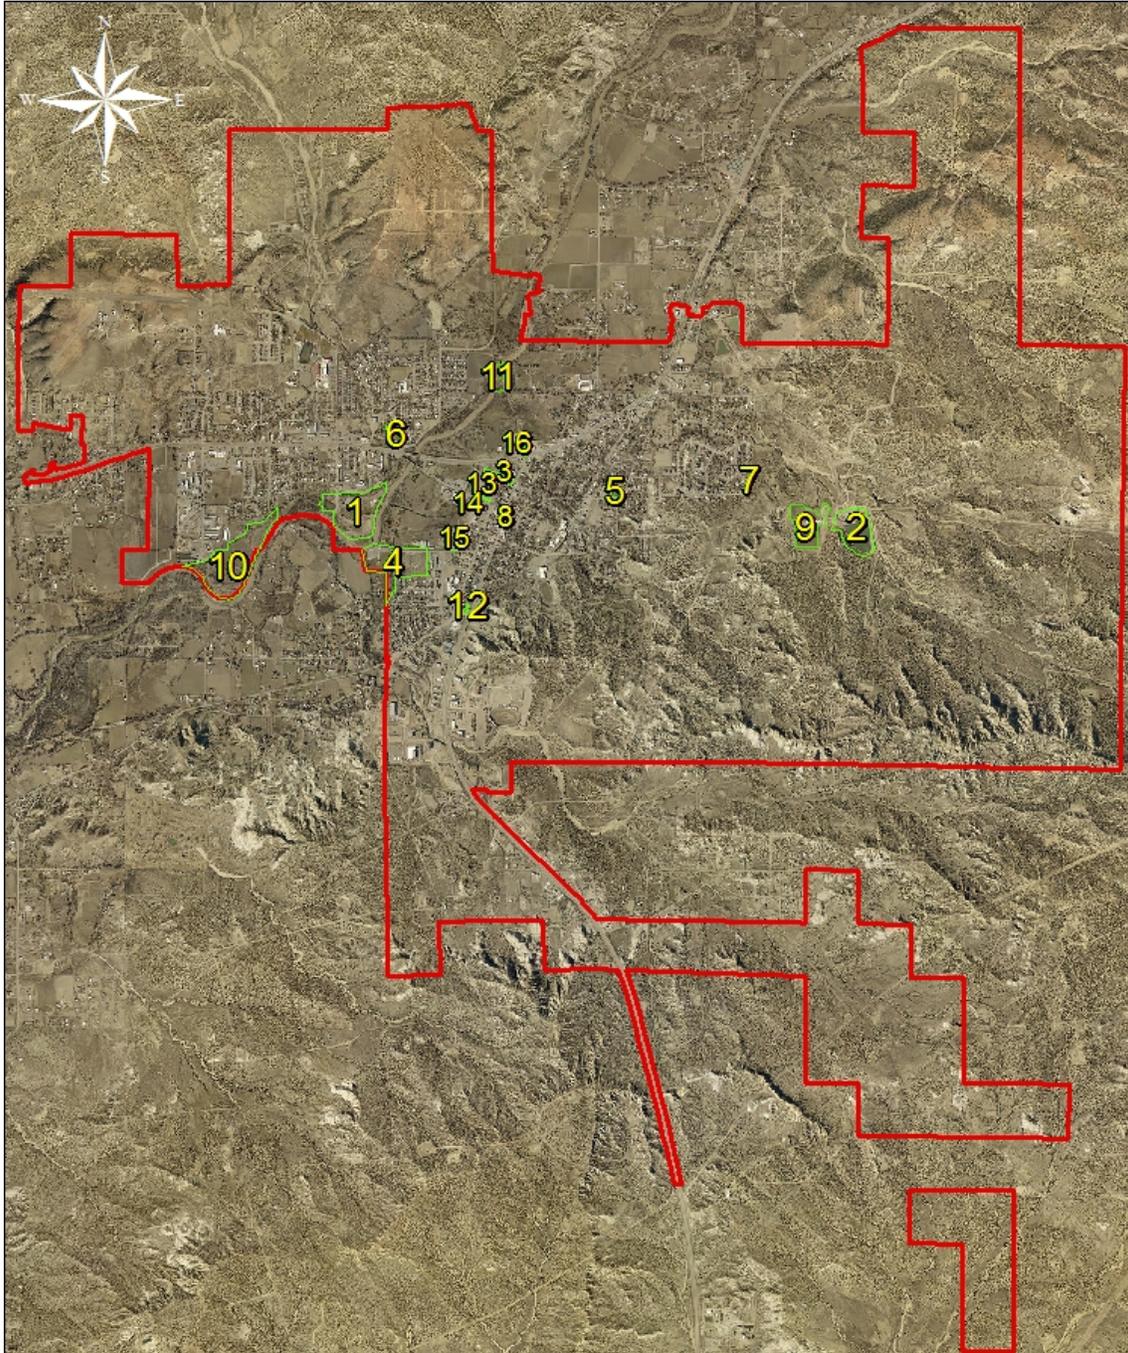
Figure 2.1. Location of City Parks and Special Use Areas.

The City of Aztec has 16 park and special use areas for an approximate total of 153.5 acres (Figure 2.1). These parks and/or special use areas range in size from 0.2 acres to 41.8 acres.

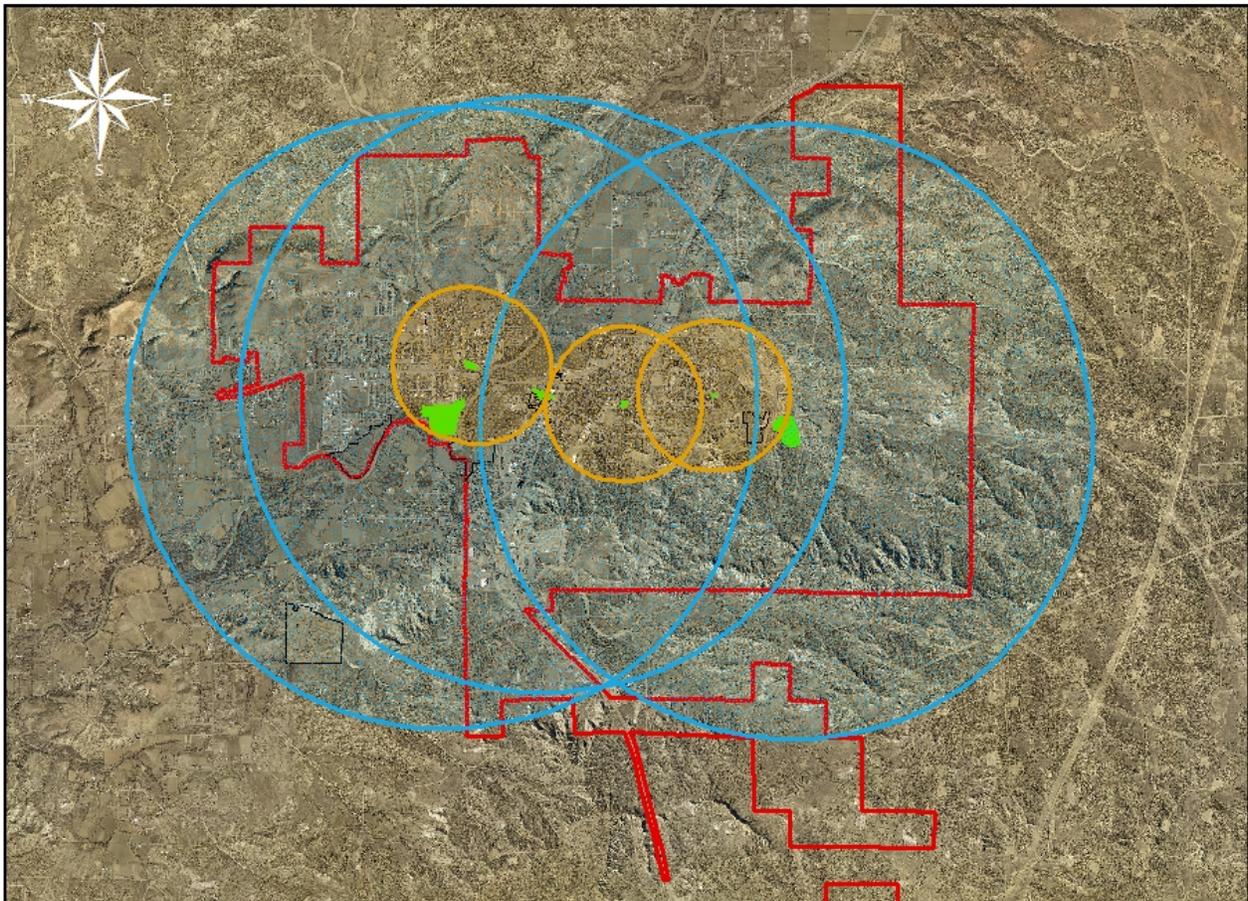
Figure 2.2. Extent of Service Areas for Neighborhood (0.5 miles in orange) and Community Parks (2 miles in blue).

Figure 2.2 shows the extent of the service area for neighborhood and community parks. As shown, all of the urban residential areas within the city are serviced by at least one community park with several urban residential areas being serviced by multiple parks based upon the service area standard established by NRPA. Only rural residential areas located far east, south, and west along city limits do not fall within the recommended NRPA service areas.

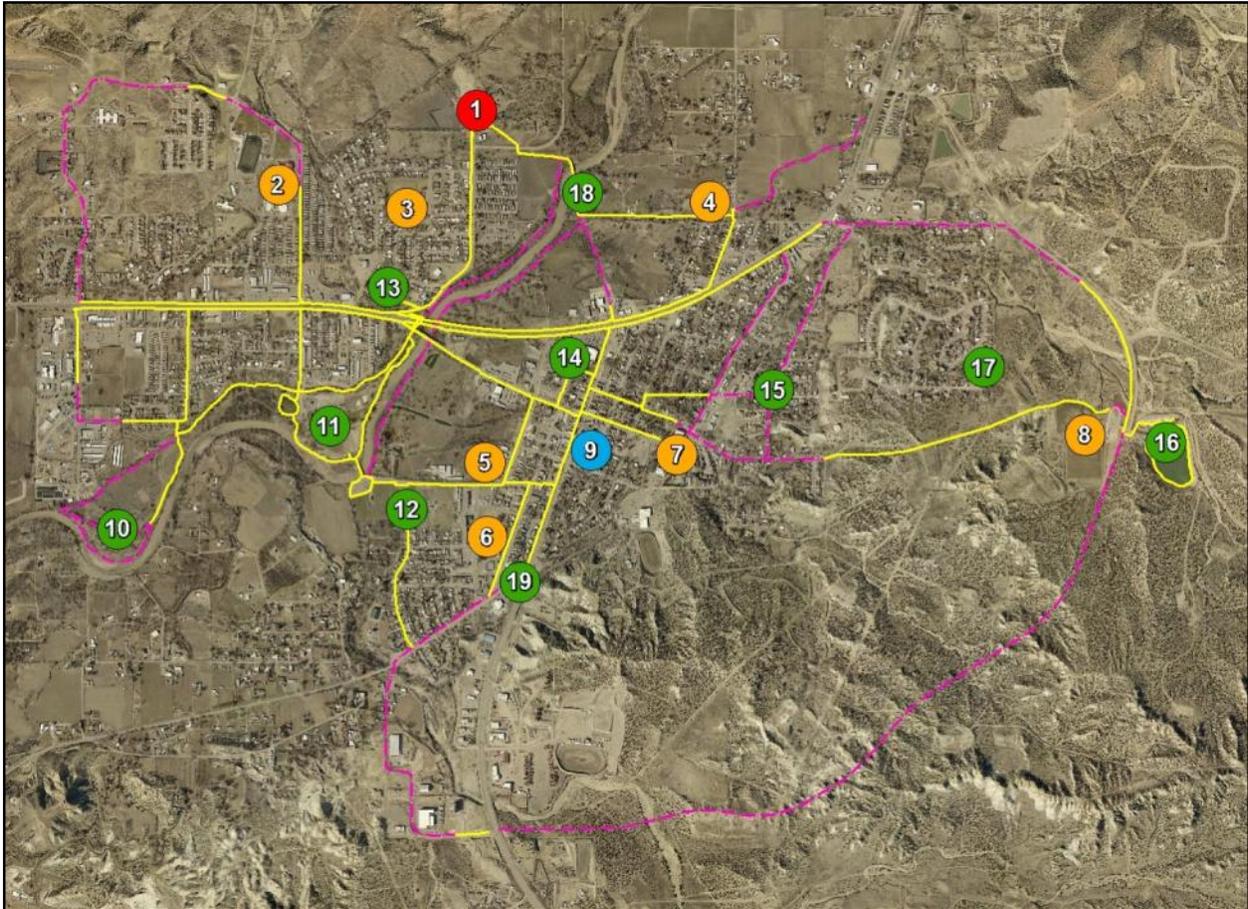
Figure 3.2. Connecting the Resources (originally taken from the ARTS Plan 2010, updated to reflect changes up to 2015).

Figure 3.2 provides a map showing the various resources and delineates the existing trails (highlighted in yellow) and proposed trails (highlighted in pink).

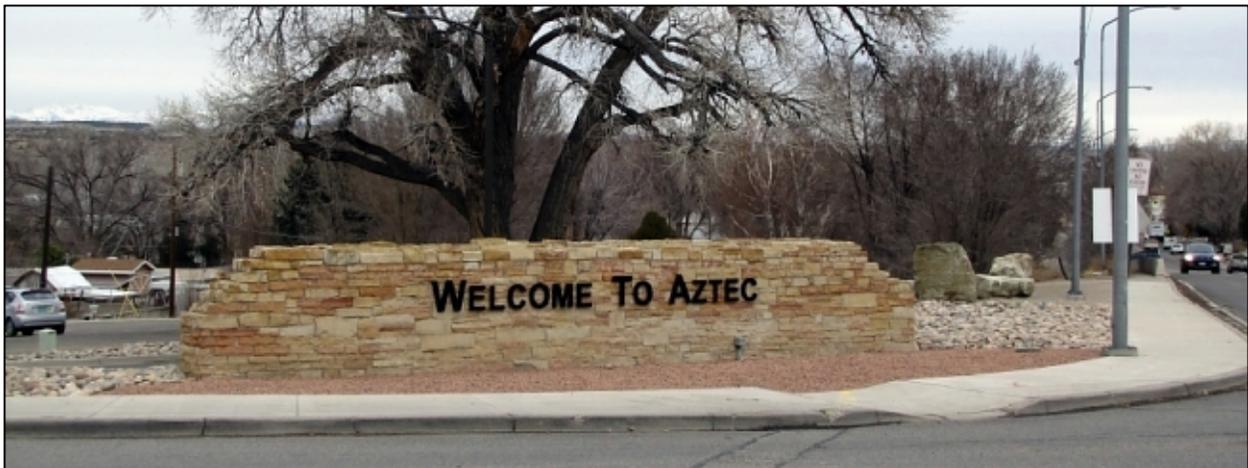
Figure 4.1. South Main Avenue Gateway with Welcome Monument Sign.

This gateway included the addition of new sidewalks to extend pedestrian access from historic downtown Aztec to the post office. The corner has a masonry wall constructed under approved NMDOT barrier walls specifications with stone masonry veneers to assimilate the Aztec Ruins National Monument pueblo structures. The slopes were cobbled and a parking lot was developed for local businesses and the public. A picnic table beneath a large cottonwood tree was installed to allow business employees or visitors to have a rest area. The work on this gateway was completed in 2013. Because of the presence of a parking lot and picnic area, this facility was assessed as a Special Use Area and has been evaluated under Section 2.

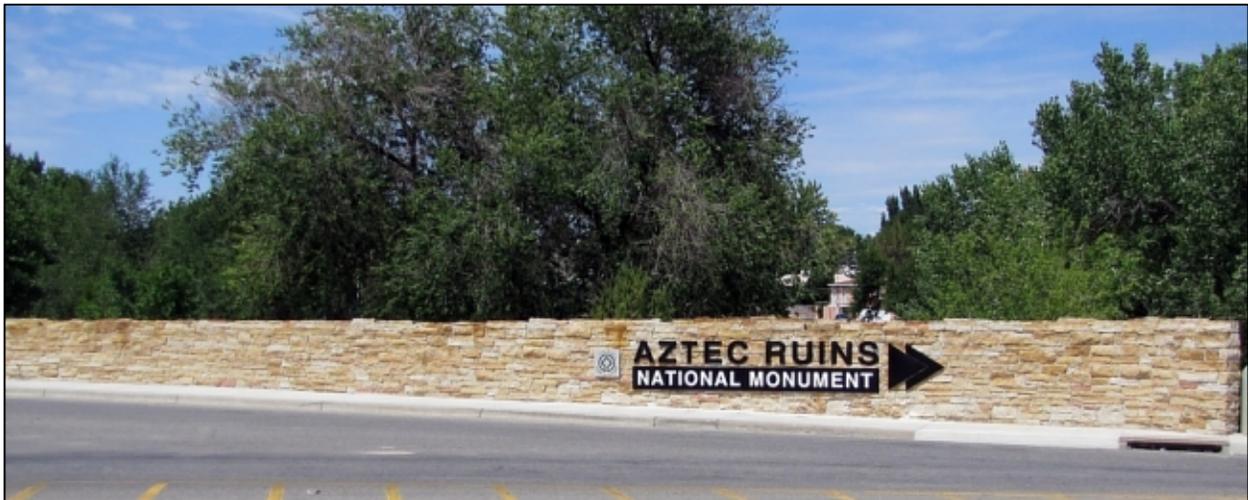
Figure 4.2. Aztec Ruins Gateway with Wall #1.

The walls were constructed under approved NMDOT barrier walls specifications with stone masonry veneers to assimilate the Aztec Ruins National Monument pueblo structures. Medians and surrounding areas were xeriscaped with cobble to minimize maintenance efforts and imitate the Animas River corridor.

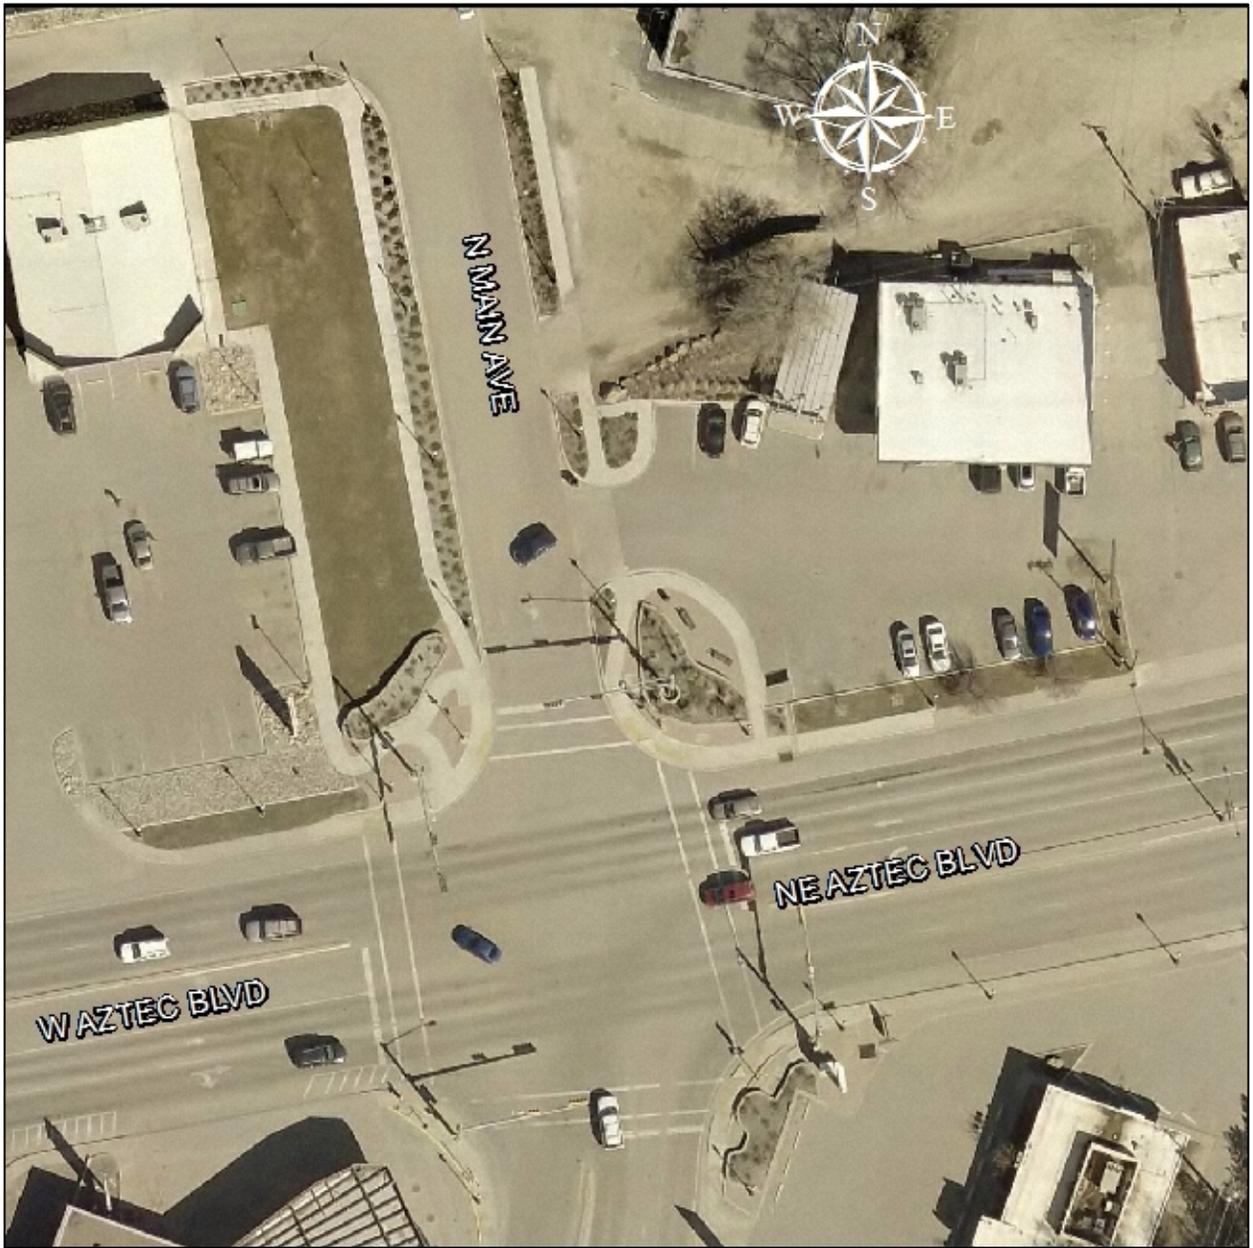
Figure 4.4. Aztec – Main Intersection.

The project has included the construction of new sidewalks, raised planter boxes, brick inlay work, installation of benches, the development of a green turf and tree areas, planting of various drought resistant plants, added street lighting, and some road median work. Because of pedestrian amenities, this area was assessed under Section 2 as a Special Use Area.

It is from this intersection that the trail system will be extended to the north to connect downtown Aztec with the Aztec Ruins National Monument. Commonly known as the North Main Corridor, the conceptual work for this trail system was provided earlier in Section 3. Construction was begun in 2015 and will continue in phases over the next 3 to 4 years.

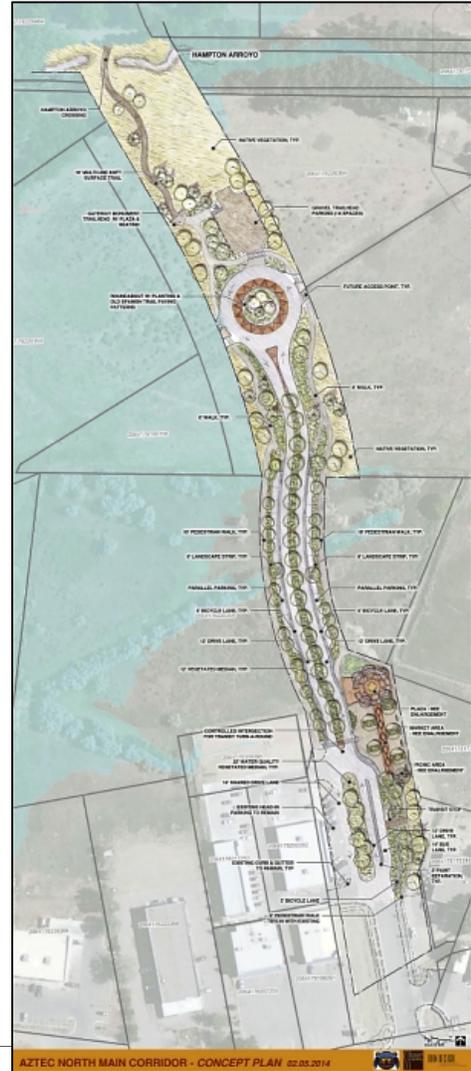
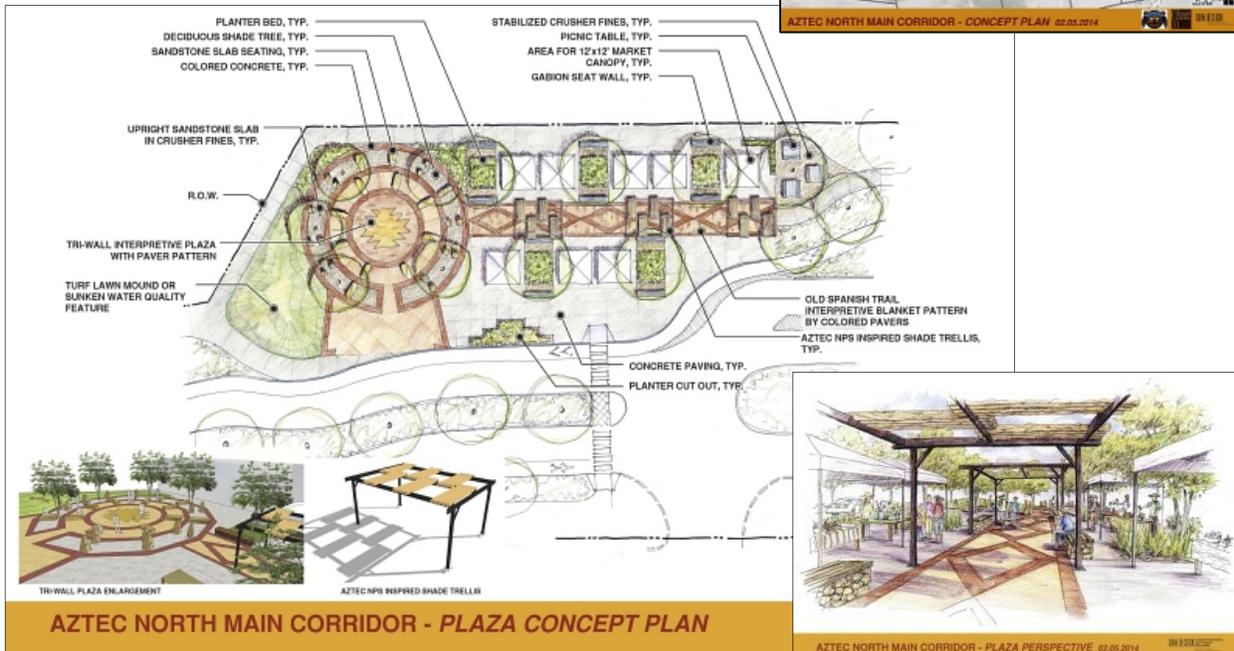
The plaza area will consist of stamped concrete and/or colored pavers in some geometric design in an interpretative blanket pattern symbolic to the blanket trading that occurred along the Old Spanish Trail. Several ramadas will be along the central pedestrian walkway as well as seating benches and landscaped islands.

Additional phases will include the construction of sidewalks and remaining street up to the roundabout. At the terminus of the roundabout will be a remote parking area and access to the trail head which leads to the pedestrian bridge across the Animas River and onto the Aztec Ruins national Monument. At the trail head will be a sandstone monument wall with traditional T-shaped entry way which is representative of several doorways located at the ruins.

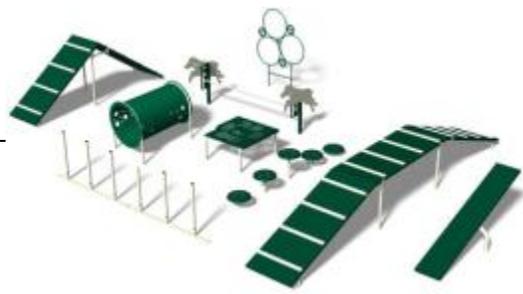
Pro Course – 9 Station

Use Zone is 70 ft x 70 ft
Bundled
