City of Aztec Parks and Recreation Enhancement Plan

September 2012

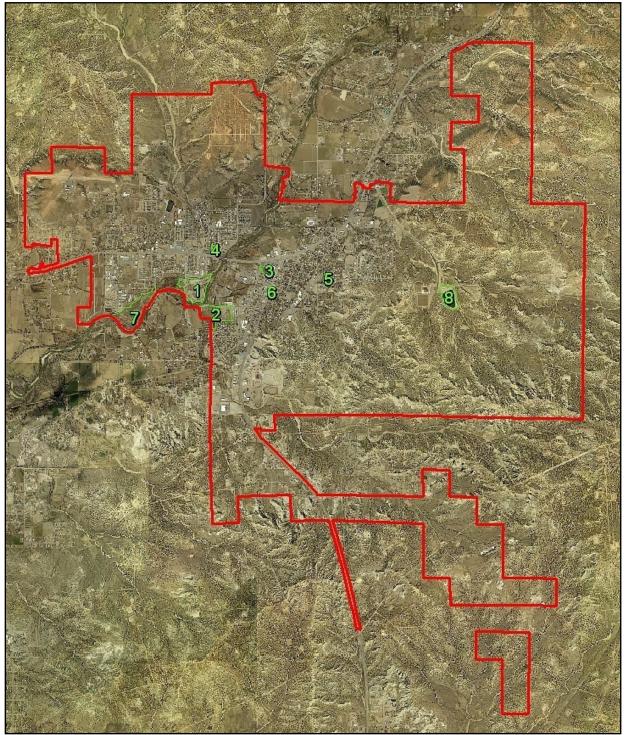
Figure 2.1. Location of City Owned Parks.

The City of Aztec has eight parks for a total of 127.47 acres (Figure 2.1). Parks range in size from 0.1 acres to 41.8 acres. A ninth park is being proposed in Kokopelli subdivision.

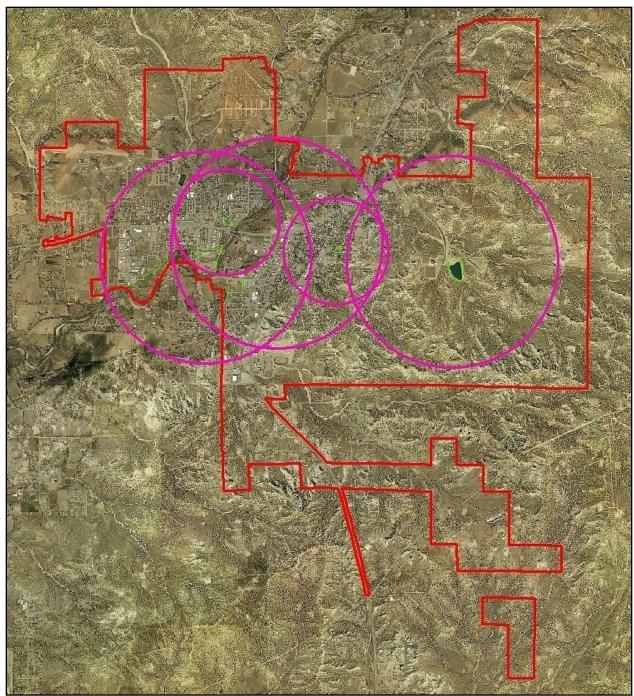
Figure 2.2. Extent of Service Areas for Neighborhood and Community Parks.

Figure 2.2 shows the extent of the service area (in pink) for neighborhood and community parks. As shown, all of the urban residential areas within the city are serviced by at least one community park with several urban residential areas being serviced by multiple parks based upon the service area standard established by NRPA. Only rural residential areas located far east, south, and west along city limits do not fall within the recommended NRPA service areas.

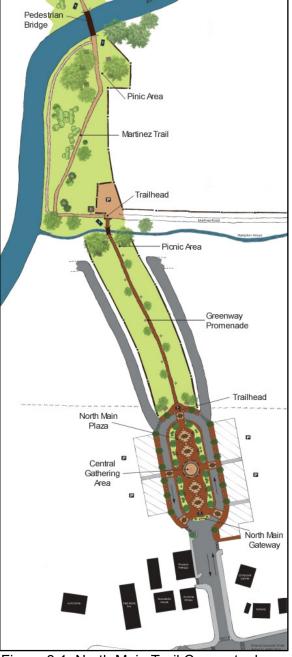
Figure 3.1. North Main Trail Conceptual.

program. The success of this trail relies on the construction of the north pedestrian bridge which is funded for construction in the year 2013. Currently the conceptual is undergoing modifications to accommodate a smaller right-of-way corridor in the area that the City still needs to acquire, adding of parking, and creating of a round-about at the end of the road system.

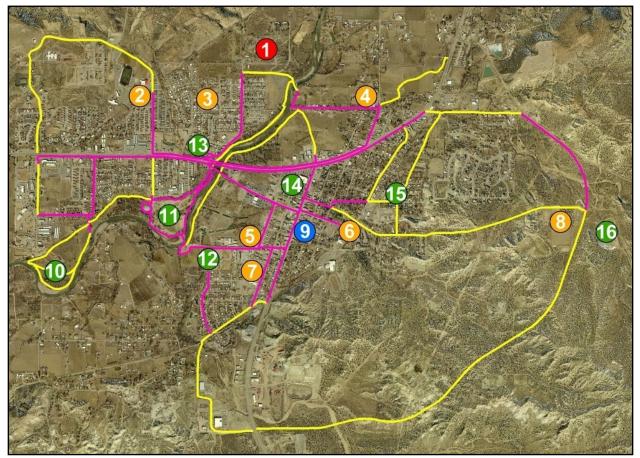
Figure 3.2. Connecting the Resources (taken from the ARTS Plan 2010).

Figure 3.2 provides a map showing the various resources and delineates the existing trails (highlighted in pink) and proposed trails (highlighted in yellow).

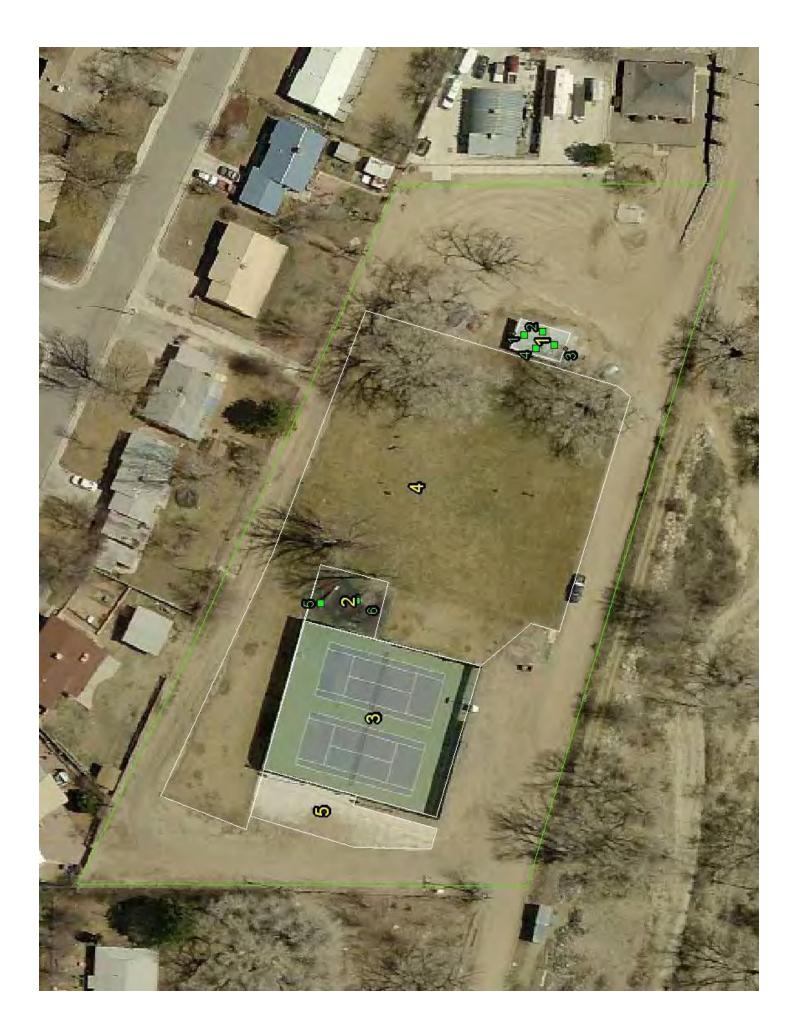
Park Name:	Hartman Park	Total Acres:	27.9	
Classification:	Sports Complex	Overall Rating:	72%	
Comments:	Better signage of field numbers need to be put on field fencing. Viewable from different angles. Trash dumpsters need pad and screened. Electric area needs to be screened. Sewer manhole at entrance needs better screening other than metal bollards. Perhaps landscape the entrance way where sewer manhole is located, good location for entrance sign.

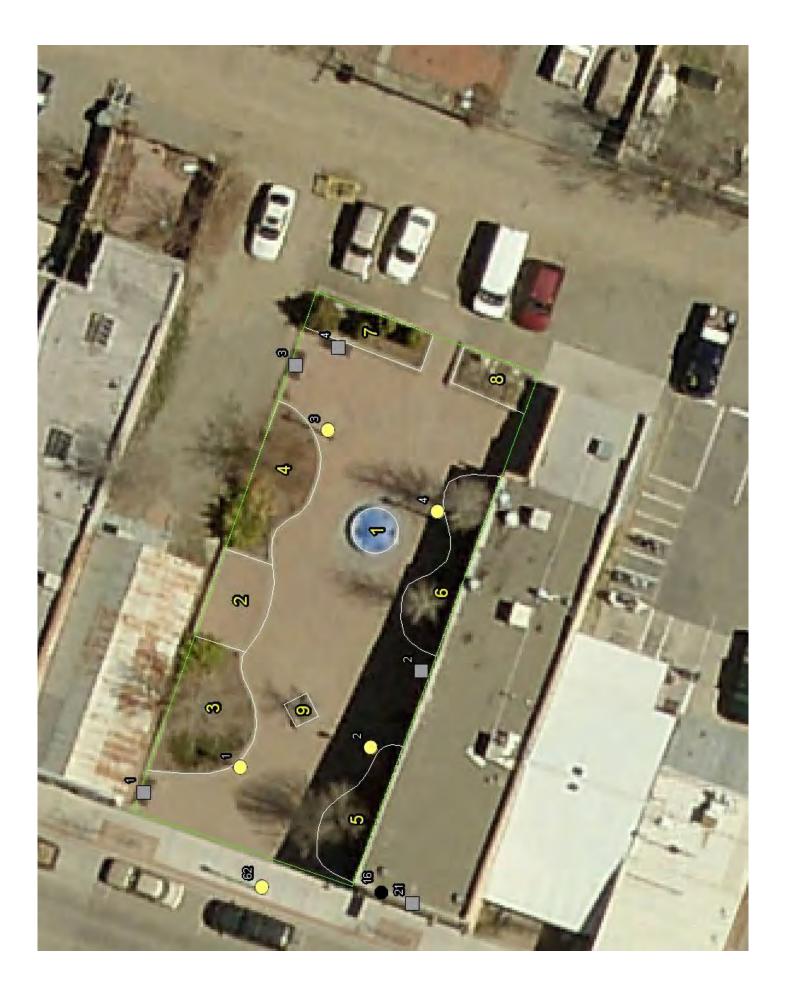
Park Name:	Memorial Rose Garden	Total Acres:	0.69
Classification:	Mini-Park	Overall Rating:	41.5%
Comments:	Trash dumpster needs pad and to be screened.

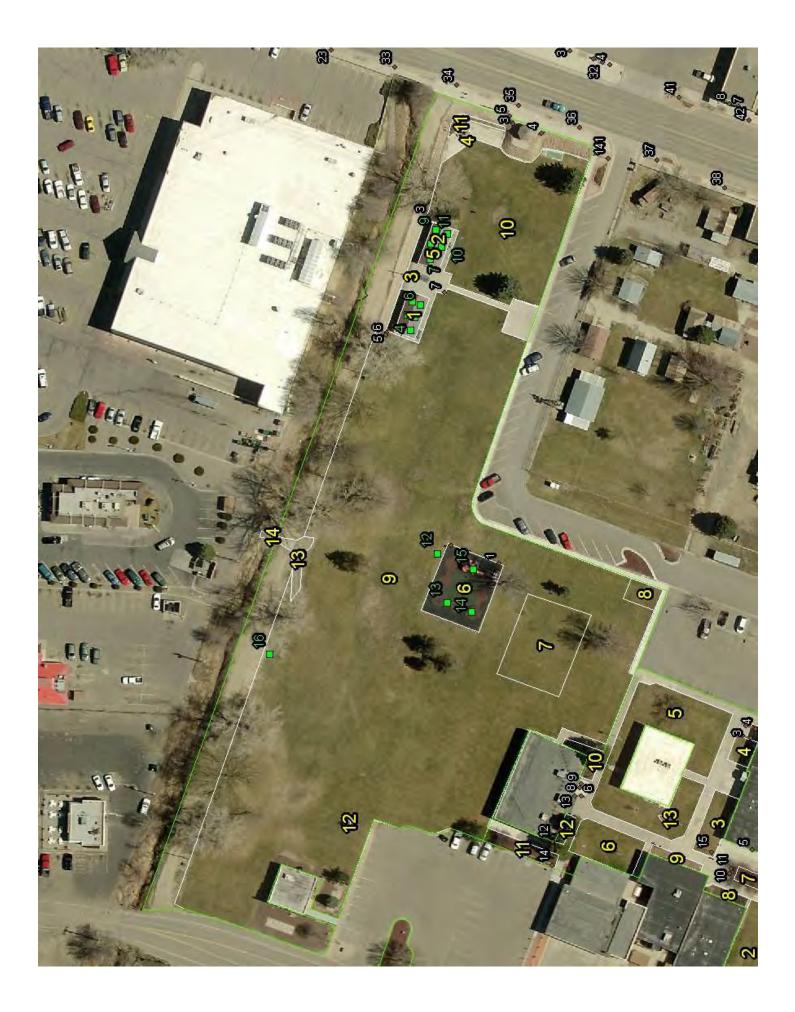
Park Name:	Municipal Complex	Total Acres:	0.88
Classification:	Special Use	Overall Rating:	85.5%
Comments:	Trash dumpsters need to be screened.
