**GEOTECHNICAL ENGINEERING REPORT  
WILLIAMS ARROYO GABION WALL REPAIR  
AZTEC, NEW MEXICO**

GEOMAT Project 232-4570

**GEOTECHNICAL ENGINEERING REPORT  
WILLIAMS ARROYO GABION WALL REPAIR  
AZTEC, NEW MEXICO  
GEOMAT PROJECT NO. 232-4570**

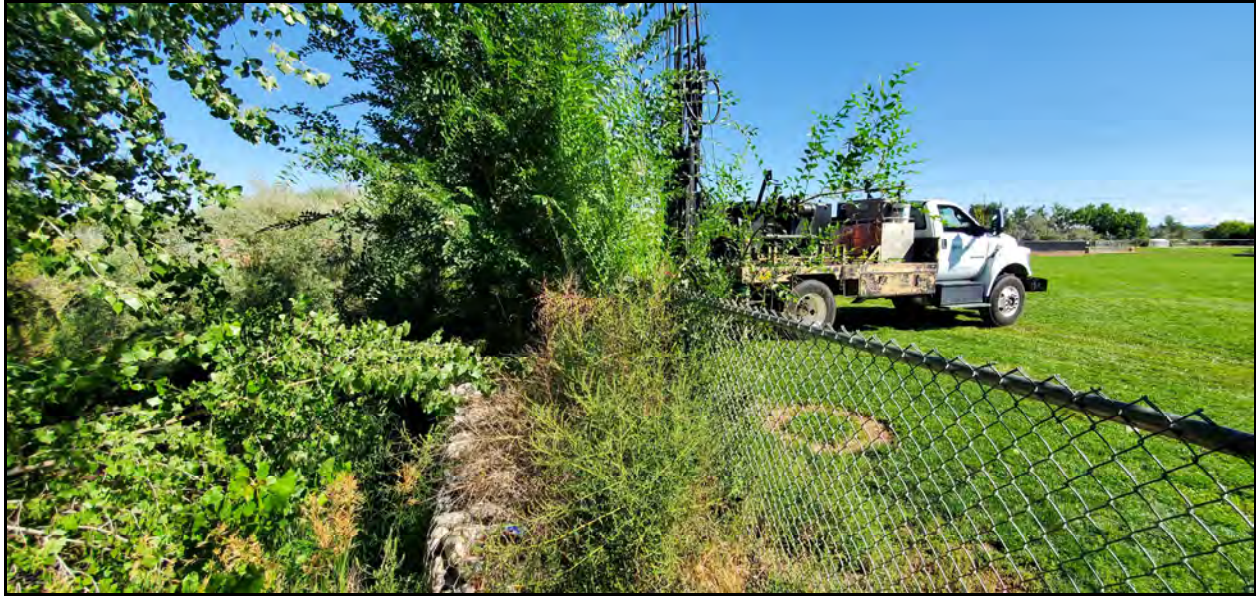
**Drill Rig at Boring B-2  
View Towards the North**

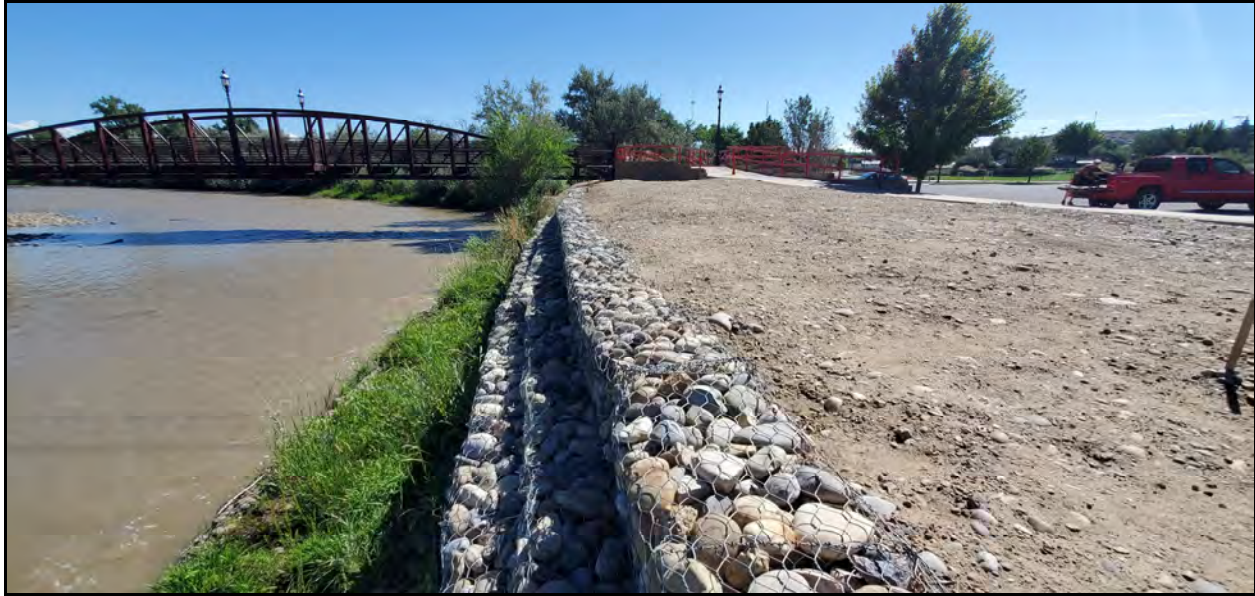
**Existing Gabion Wall along Animas River near Boring B-5  
View Towards the East**

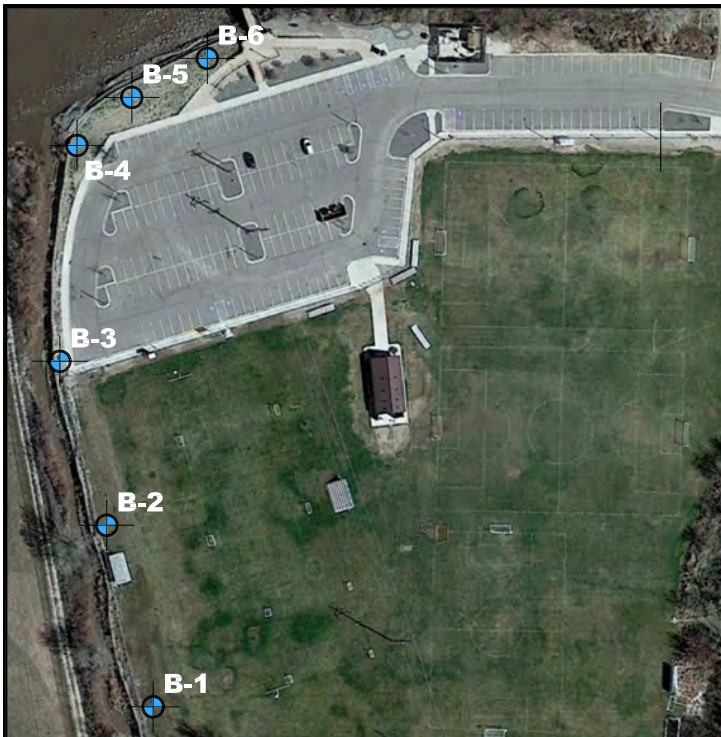
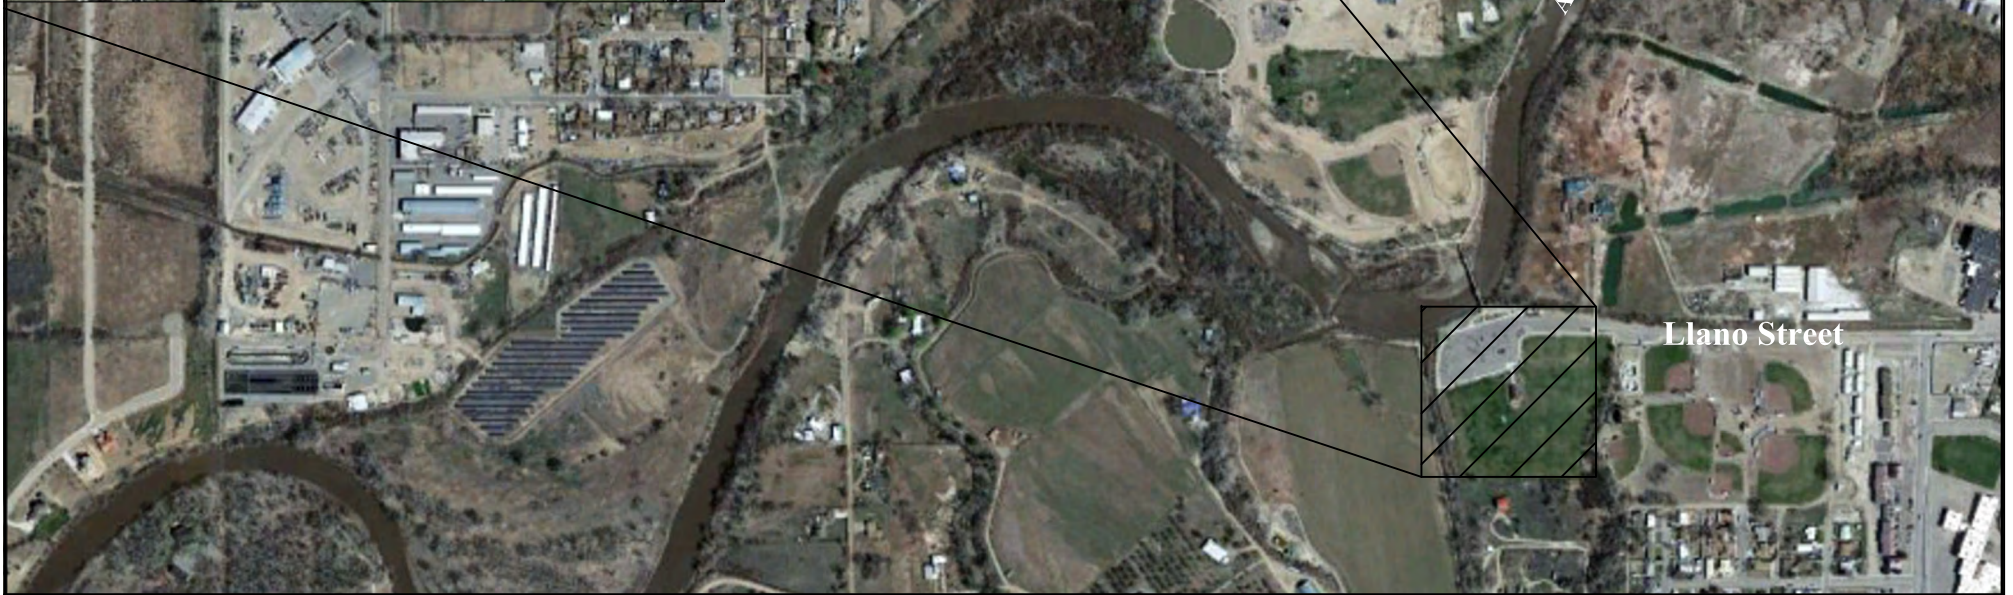
Approximate Not to Scale	VICINITY PLAN	PROJECT

<b>GEOMAT</b> INC.
	Boring Locations (approximate)		
	GEOMAT Project No. 232-4570 Date of Exploration: August 28, 2023		
		<b>Williams Arroyo Gabion Wall Repair</b> <b>Aztec, New Mexico</b>

Subsurface conditions at the site were explored on August 28<sup>th</sup>, 2023, by drilling a total of six (6) exploratory borings at the approximate locations shown on the Vicinity Plan in Appendix A. Borings B-1 through B-6 were drilled along the arroyo channel to an approximate planned depth 15 feet below existing ground surface (bgs).

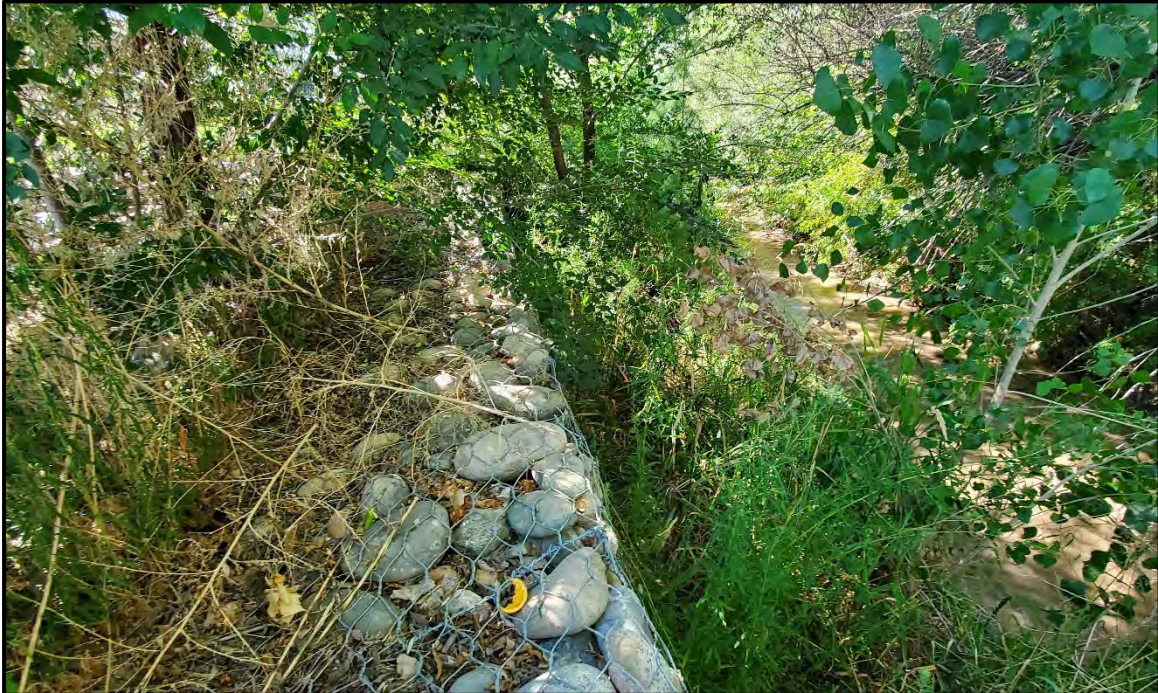
**Gabion Wall near at Boring B-2  
View Towards the South**

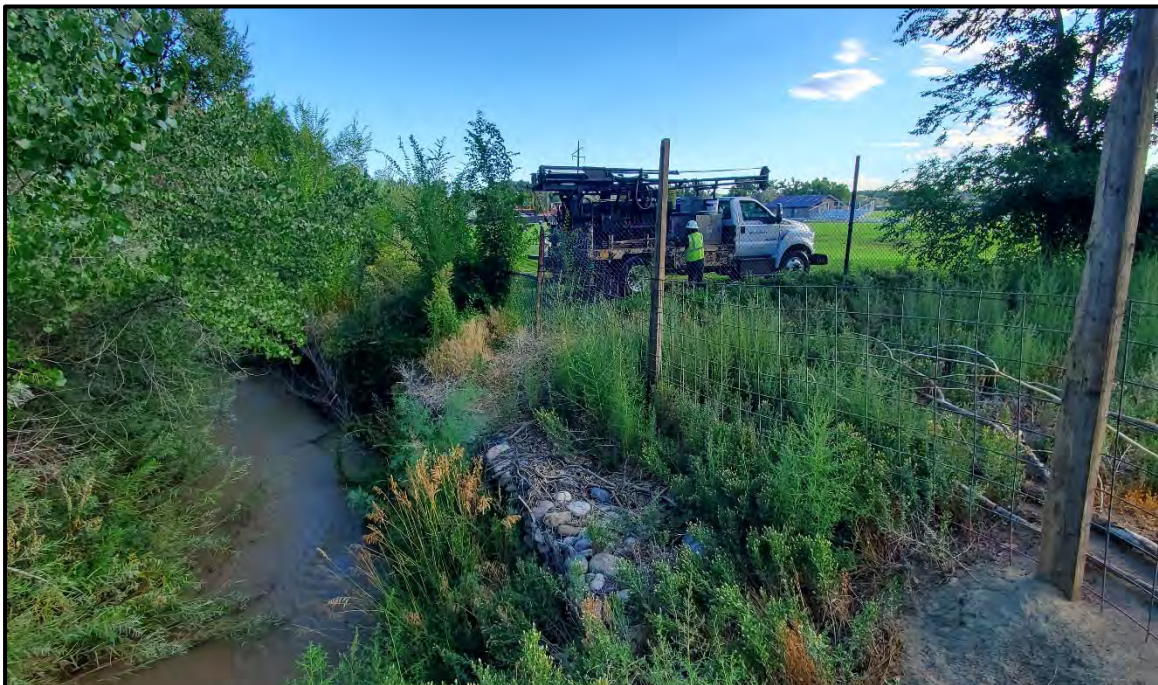
**Drill Rig at Boring B-1  
View Towards the North**

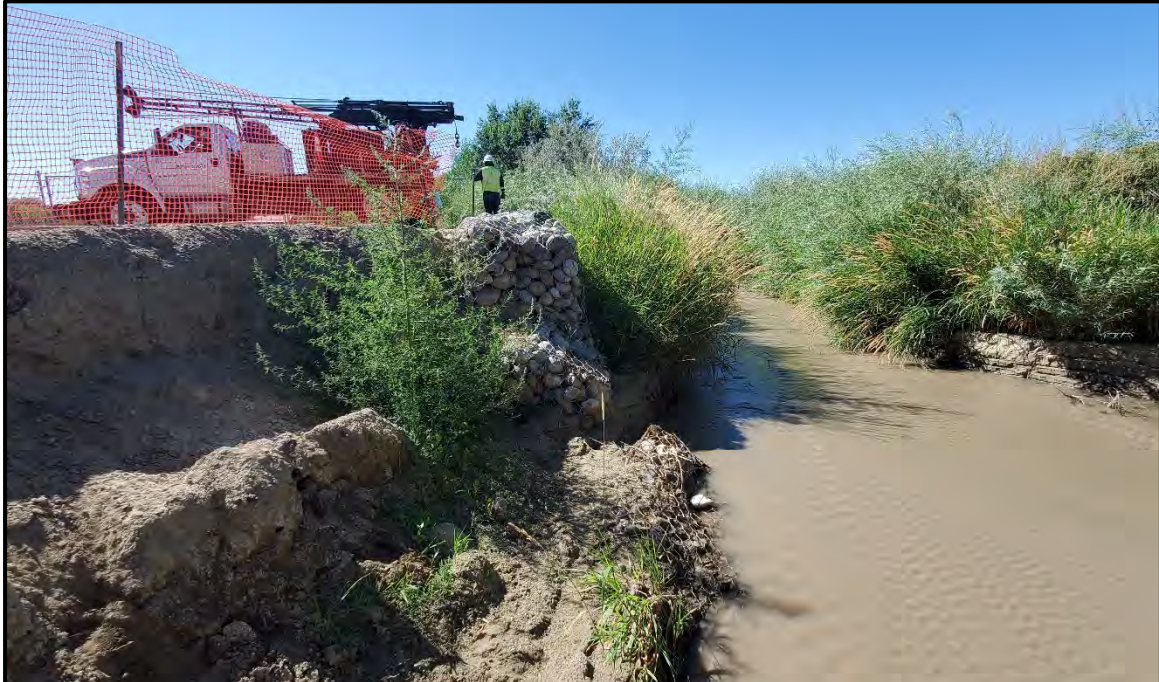
**Damaged Gabion Wall near Boring B-3  
View Towards the South**

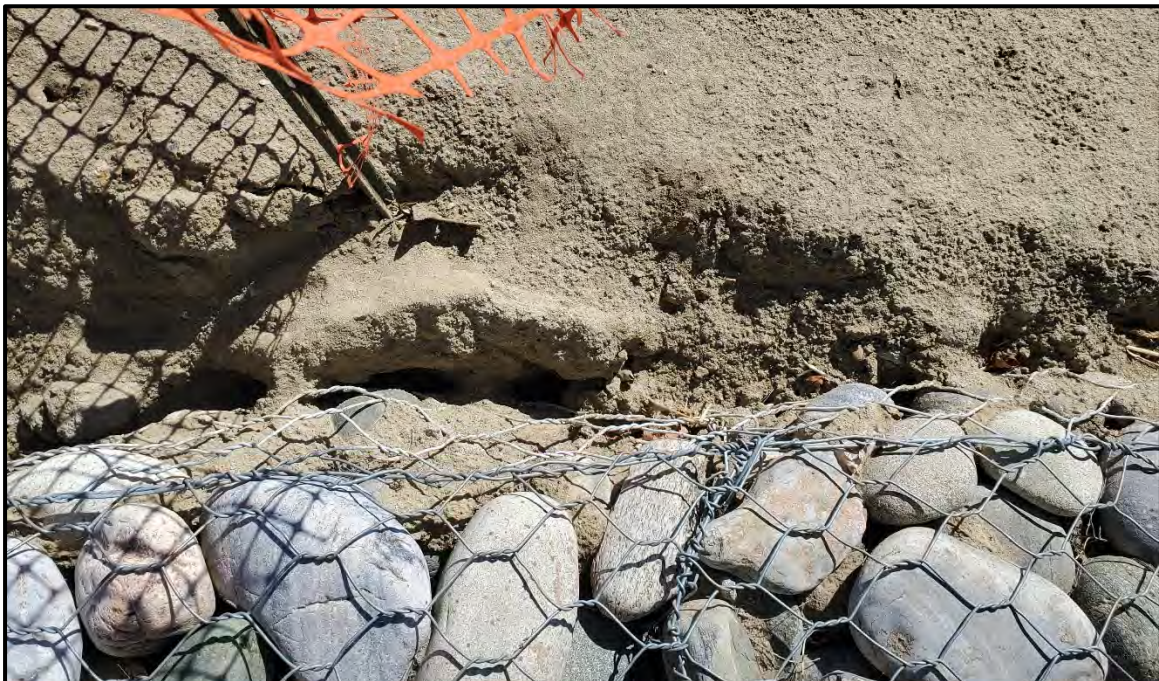
**Piping behind Damaged Gabion Wall near Boring B-3  
View Towards the East**

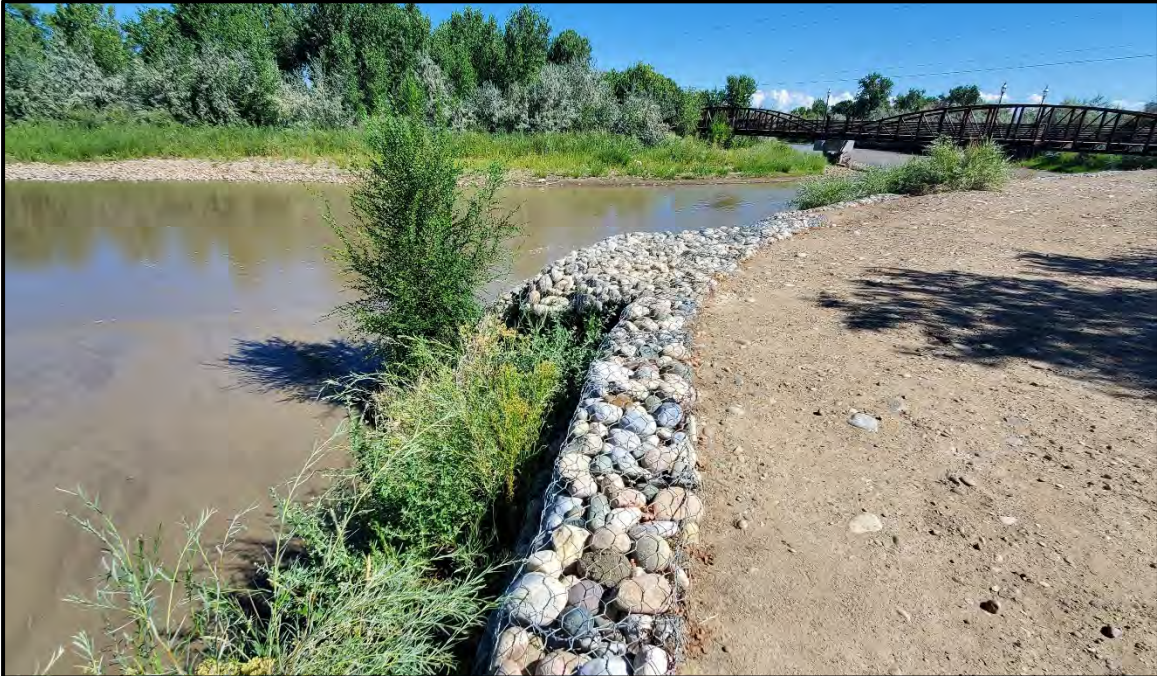
**Gabion Wall near Boring B-4  
View Towards the Northeast**

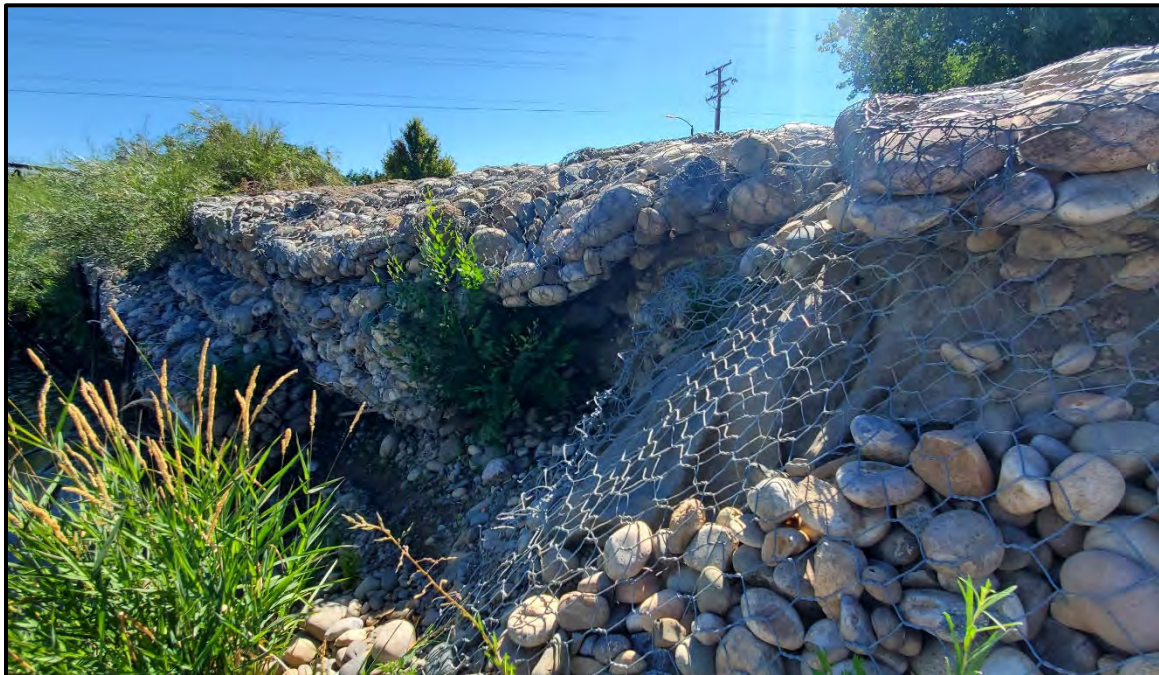
**Riverview of Gabion Wall near Boring B-4  
View Towards the East**

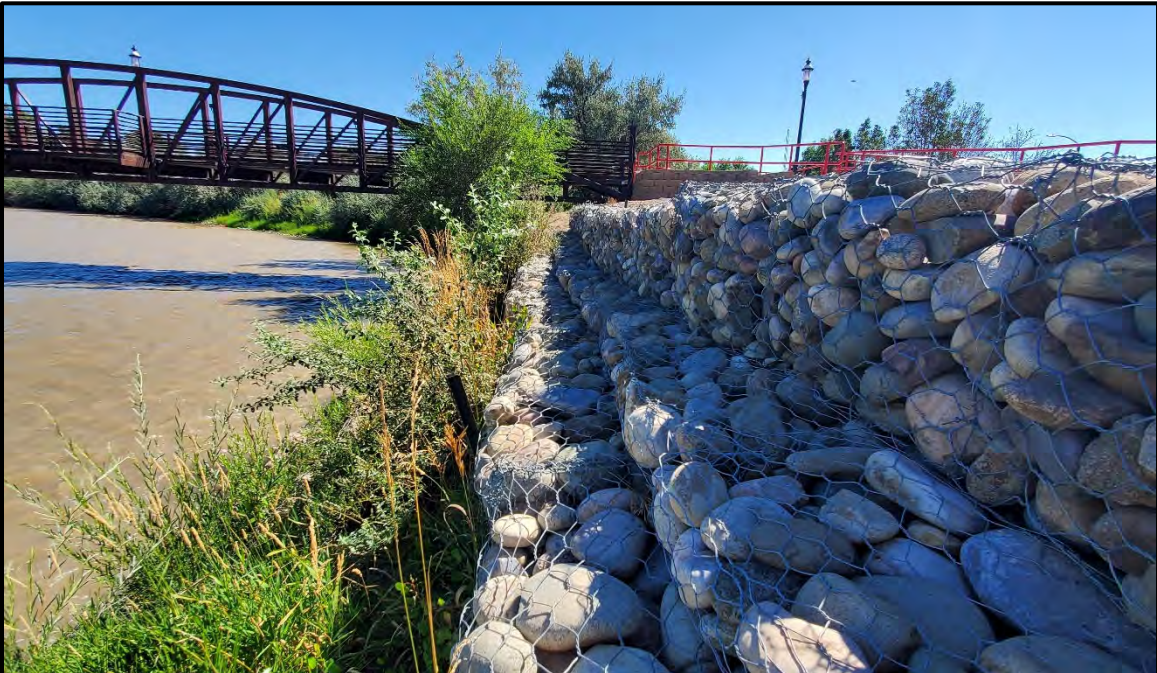
**Riverview of Gabion Wall near Boring B-5  
View Towards the East**
